JACK SNIDER, III

Take-Home Asbestos Exposure 2011 Topics

Take-Home Asbestos Exposure

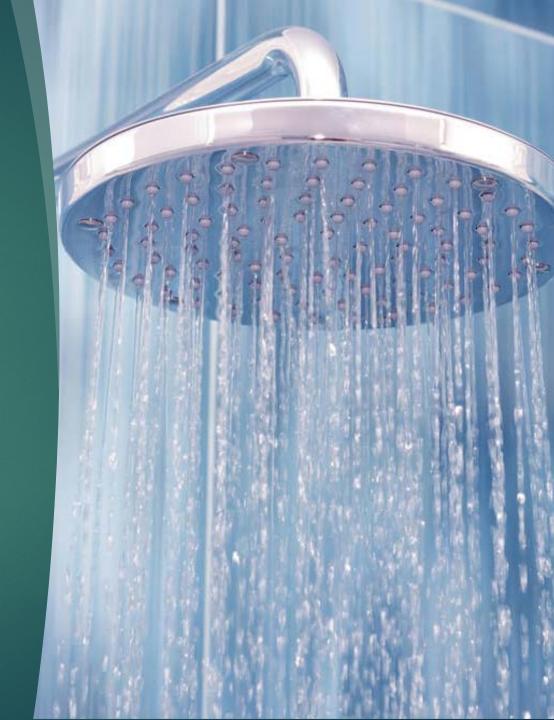
- Showers may not be connected to a water source and HEPA filtered vacuums may never be used.
- Owners/Supervisors/Workers go through the motions of making the abatement project appear compliant.

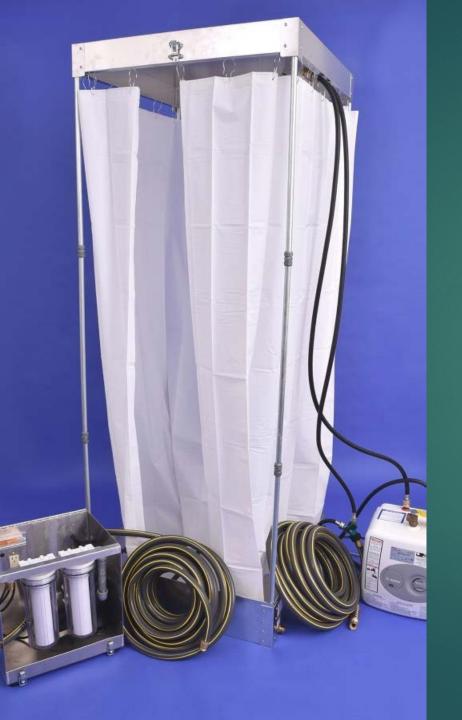
Water filters may not work:

► The illusion consists of showers that are not connected to a water source and sometimes even the work area.

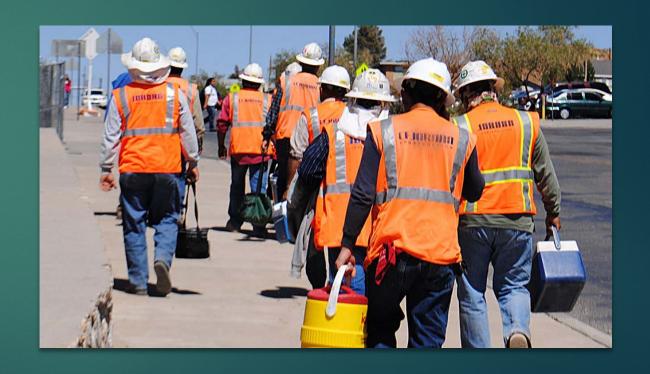
During the removal of floor tile, mastic, and other non-friable ACM, workers are typically wearing street clothes into the work area, and they are not showering nor vacuuming themselves/their clothing upon exiting the containment.

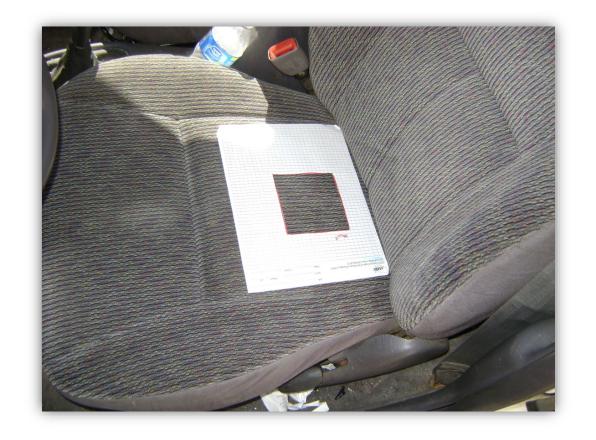
SAMPLE LOCATION 14:

75,200 STRUCTURES/CM²

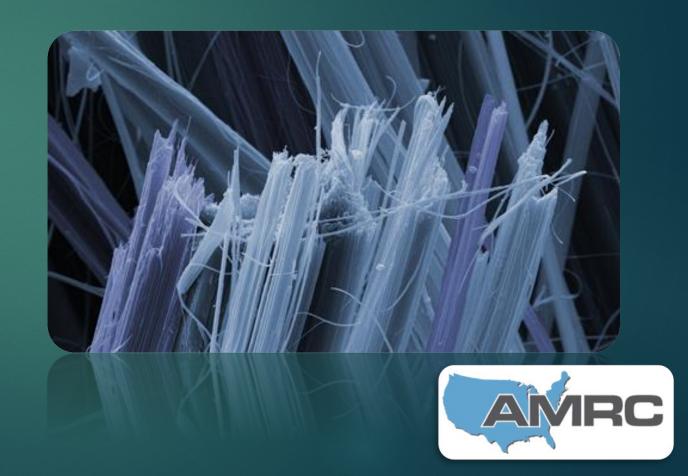
Sample Location 17:

- Concrete floor leading up to work area entrance of a floor tile abatement project
- ▶ 762,000 structures/cm²

- ► The data suggests that abatement practices on many asbestos removal projects are missing the purpose.
- Consultants/Contractors/Building owners must be responsible for conducting removal work correctly.
- We must remember that <u>asbestos is a silent</u> killer!

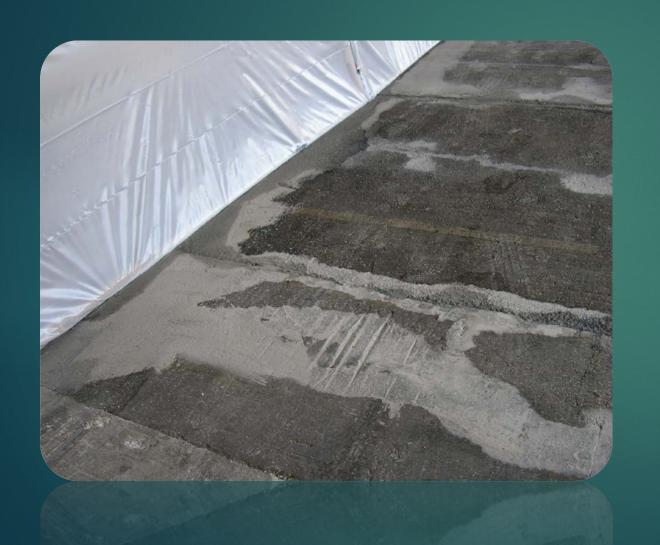
Sample Location 18:

- ► Floor area inside the containment after floor tile was removed
- ▶ 1,540,000 structures/cm²
